PROBLEMS OF BENDING

DIMENSIONAL DEFECT AND ANGLE DEFECT

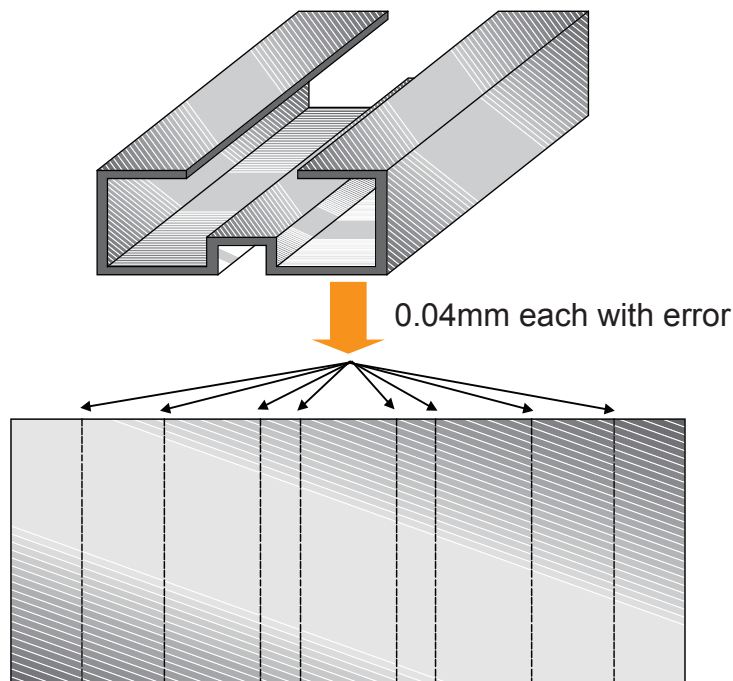
Defective example: SUS 1.5t, bending process in 8 steps resulted in a difference of $\approx 0.32\text{mm}$ from the dimension in the developed view (within tolerance). A single bending gives an error of 0.04mm.

And then, when the tool was inspected, it was found that the tip of the punch was worn at $R0.2 \rightarrow 0.6$ and the die shoulder was at $R0.6 \rightarrow 1.0$.

In the tool, the punch tip radius and the die shoulder radius are worn.

As the wear proceeds, the bending allowance will change, which may lead to defective product dimensions. In addition, it may be difficult to identify the cause when using a combination of tools with either one of the punch and die worn.

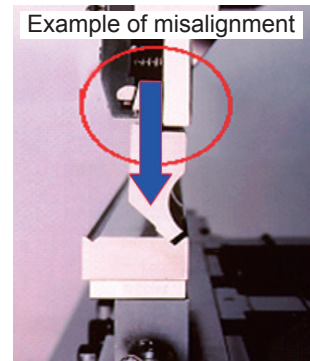
Example of misalignment

1. Perform the aligning operation again. If the center is misaligned, the wear proceeds. Finding early can return the dimensions.
2. If you are using sectionalized 2V die rails, double check that there are no gaps between the rails.
3. In the case of step bend, change the tool mounting position. Machine cylinders are pressurized at both ends and pressurized at the center, but the bending accuracy may vary slightly at the position where the product is bent.
